APPENDIX H

Wetlands

Our office has reviewed your approved jurisdictional determination received September 5, 2024, concerning the proposed Sioux Gateway Airport expansion located at 2403 Aviation Boulevard, Sioux City, Section 36, Township 88 North, Range 48 West, Woodbury County, Iowa. (42.4145 / -96.40695)

Wetland & Waters of the US Delineation Report Sioux Gateway Airport

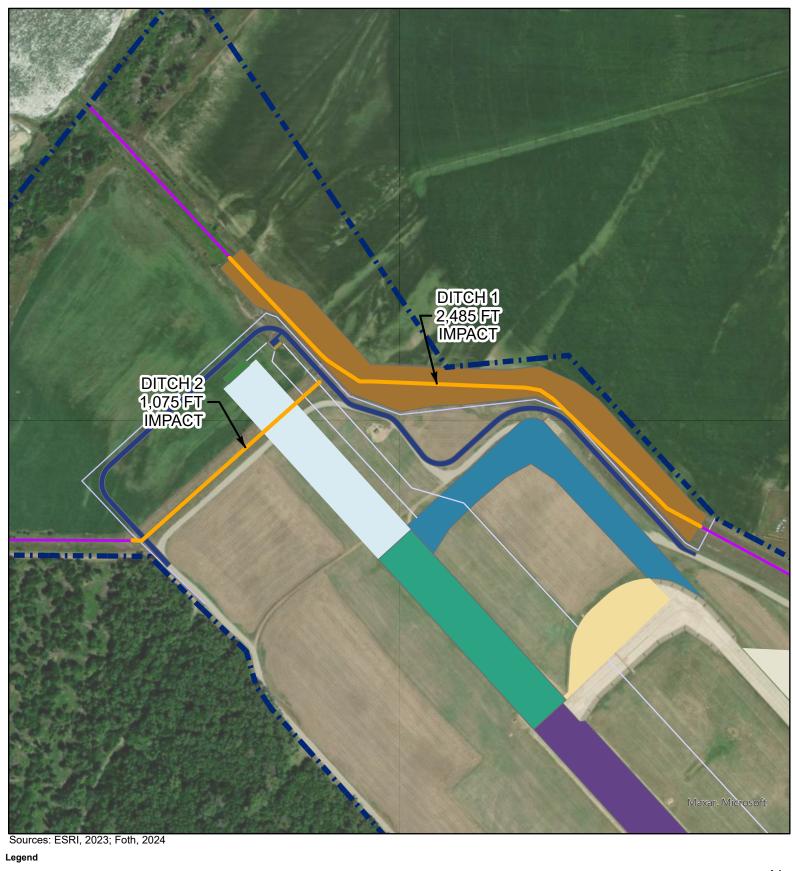
Figure 2A Proposed Action Map

Project Study Area Drainage Ditch Realignment Perimter Road Realignment Non-Jurisdictional Feature Fence Realignment Runway Extension Non-Jurisdictional Feature Impact Localizer Relocation Runway Reconstruction 200 400 900 NAVAID Shelters Construction Blast Pad Construction **Taxiway Construction** ■ Feet Warm Up-Holding Pad Construction Cables Replacement Pavement Demolition

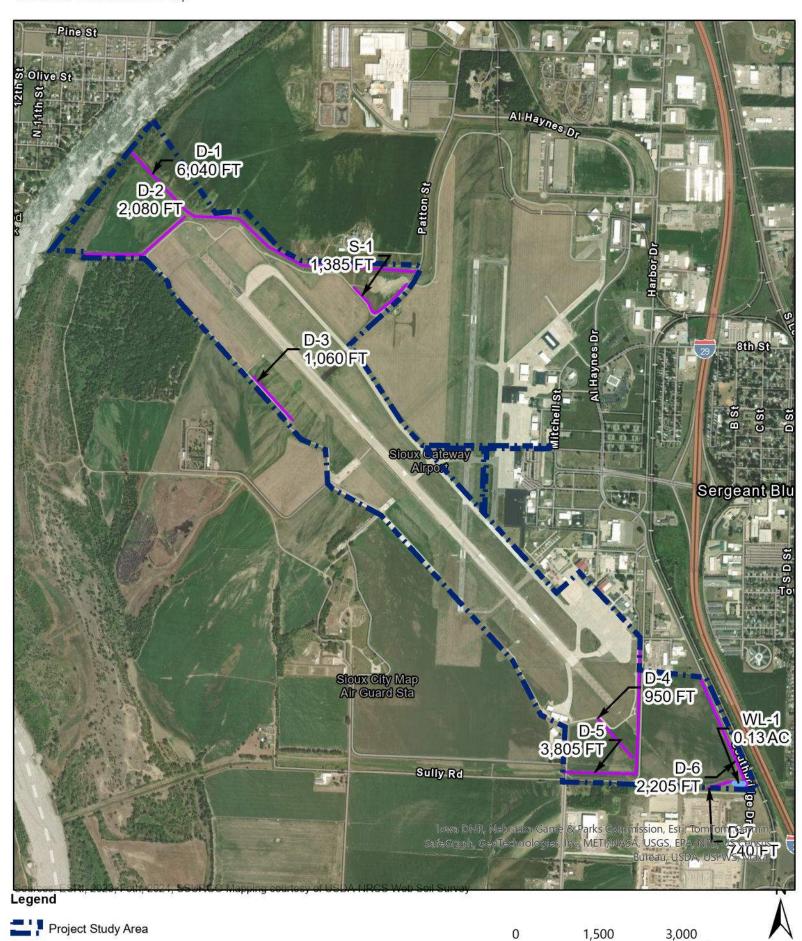
Figure 6 Wetland Delineation Map

On May 8, 2024, Foth performed fieldwork and identified wetlands and drainage features within the Project Study Area, as depicted on Figures 6 through 6C. Appendix B contains the Wetland Determination Data Forms for the wetland area. Ground photographs, included in Appendix C, provide an indication of the physical characteristics observed during the site visit. The following sections describe the wetlands and drainage features identified during the delineation.

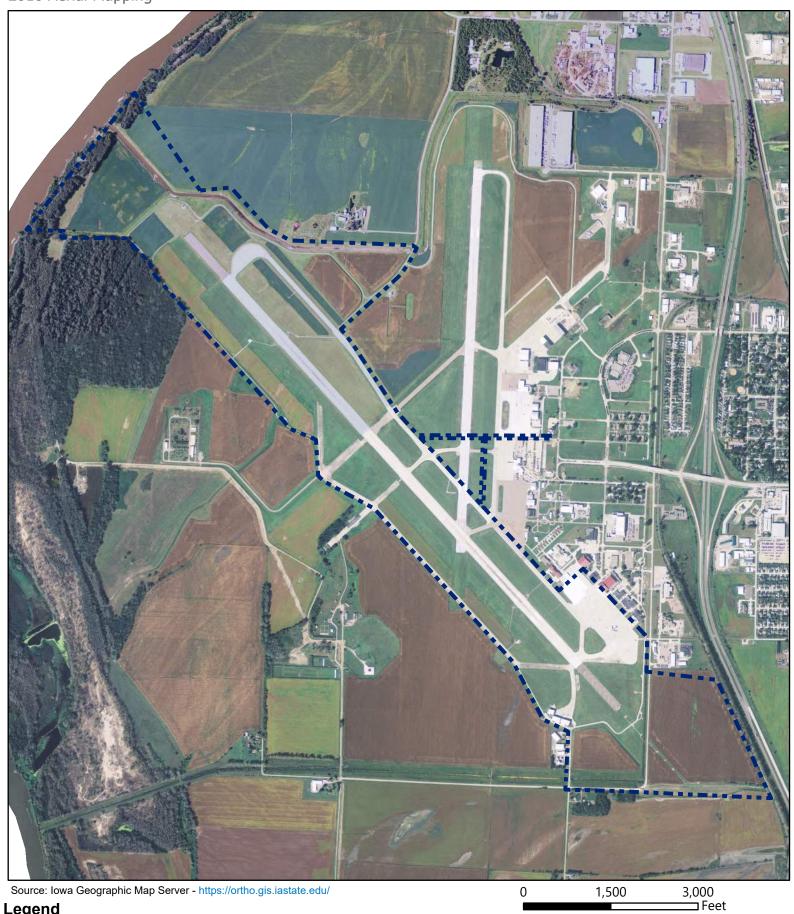
Figure A9 2010 Aerial Mapping

The Lower Missouri River sustained three devastating floods within 30 years: 1993, 2011, and 2019 (Google, 2024). 2010 is also historically noted as a year with above-normal precipitation and flooding. The flooding events in 2011 and 2019 and the high rainfall events in 2010 correspond with flooding of D-1 depicted on the historic aerials.

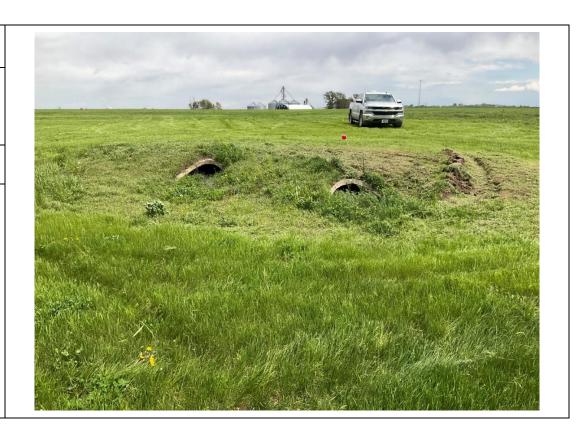
Description:Culverts between the taxiway and runway

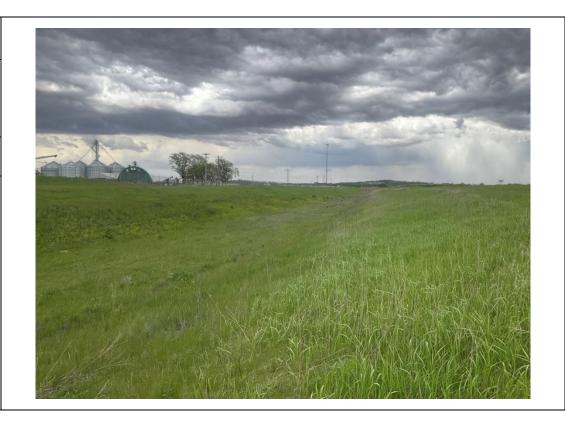
According to Rich Johnson, a consultant who has worked for the Airport Sponsor for 18 years, D-1 only contains water when the levels in the Missouri River are at flood stage and water within the ditch is generally a result of backup from the river rather than flow from upland areas. During the site visit, Foth observed the bottom of the ditch to be dry and completely vegetated despite precipitation being two to three times greater than the normal range in the 7 and 30-days prior to the site visit. There was no evidence of drainage patterns that would indicate frequent or sustained flow within the ditch. See Table 2-3 in Section 2.6 for a summary of the history of the ditch based on aerial photograph observations. The years of historic flooding or

above-normal rainfall in 2010, 2011 and 2019 correspond with observed water within D-1 on historic aerials.

Description: View of D-1

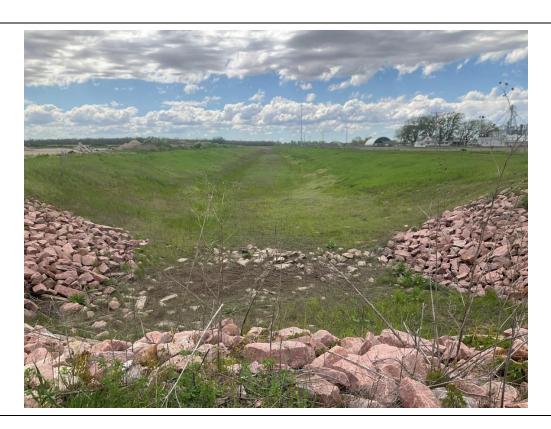
Description: View of D-1

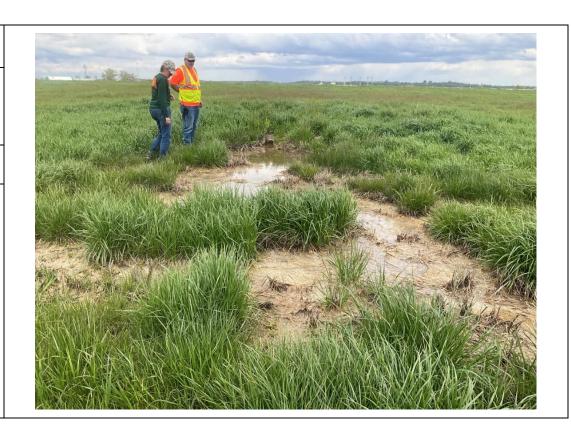
Tile outlet beneath the runway. A data point was not collected at this location due to the dominance of upland vegetation. Standing water was likely due to recent heavy rainfall.

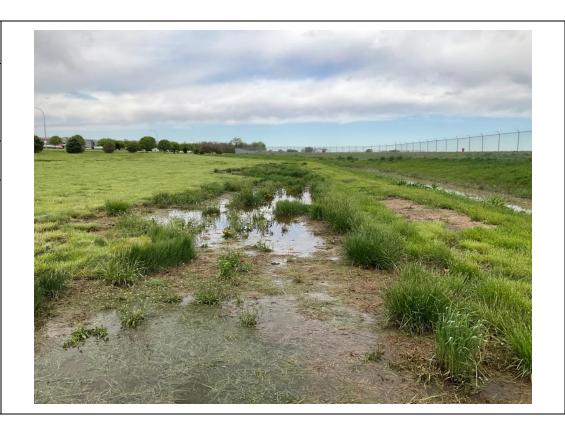
Description: View of the area near DP-16, DP-17, D-7, and WL-1

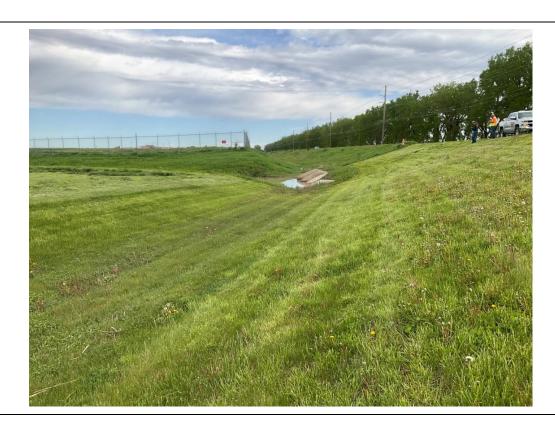
Description:View of D-6 and WL-1
